T.I. No.: 2023-18b Updated: 03/10/2023	Subject: Failure of solid-state relays (update)
--	--

Follow up defective solid-state relays

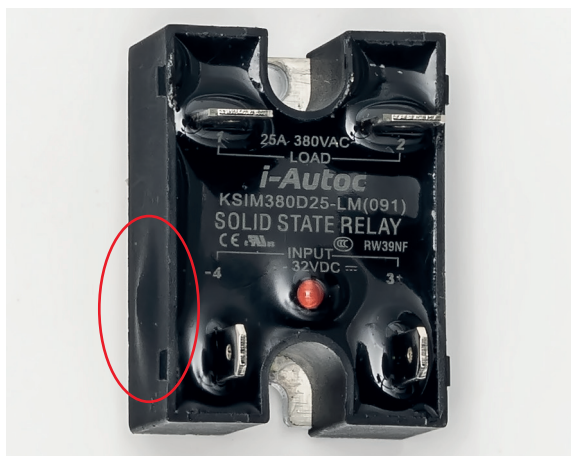
Figure 1: Solid-state relay, article no. 072044

Regretfully, after detailed investigations at our supplier, an additional production lot of solid-state relays has been identified as potentially affected. Next to lot **RW39**, lot **RX14** may have the same faulty component built-in (Varistor). (All other SSR production lots have varistors from a different supplier or a different varistor production lot).

A failed relay can look intact from the outside or burnt to varying degrees (see example picture). In many cases, one of the safety thermostats (Klixons) tripped. In isolated cases, the power board had to be replaced.

- ▶ Check the production code of the solid-state relays.
- ▶ If the relays are from the **RW39** or **RX14** production lots: Replace all relays.

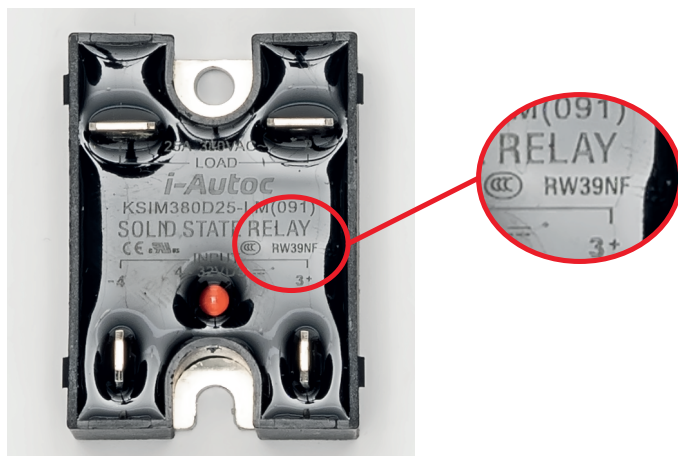
Figure 2: Faulty production lot

Potentially faulty relays are from the production lots **RW39** and **RX14**. The last two characters (NF in the example) are insignificant, see illustration above.

- ▶ Check the spare parts stock for the presence of solid-state relays with production codes **RW39** or **RX14**.
- ▶ Sort out solid-state relays with production code **RW39** or **RX14**.
- ▶ Machines in stock: Check machines in stock before or during installation.
