T.I. No.: 2023-18c Updated: 10/10/2023	Subject: Failure of the solid-state relay (update II)
--	--

Follow up defective solid-state relays

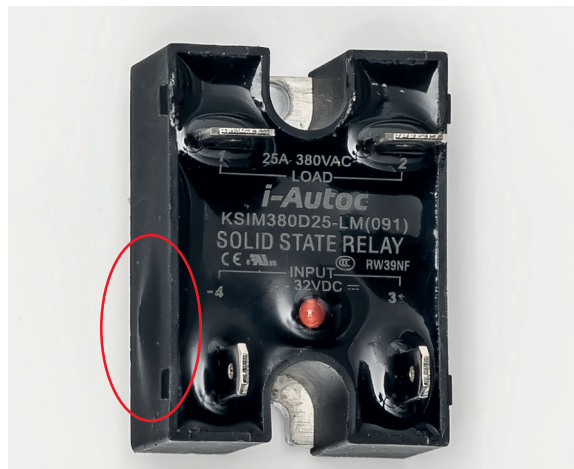
Figure 1: Solid-state relay, article no. 072044

Regretfully, after detailed investigations at our supplier, an additional SSR production lot has been identified as potentially affected. Next to lot **RW39**, lot **RX14** may have the same faulty component built-in (Varistor). All other SSR production lots have varistors from a different supplier or a different varistor production lot.

A failed relay can look intact from the outside or burnt to varying degrees (see example picture). Often, one of the safety thermostats (Klixons) will trip. In isolated cases, the power board requires replacement.

- ▶ Check the production code of the solid-state relays.
- ▶ If the relays are from the **RW39** or **RX14** production lots: Replace all relays.

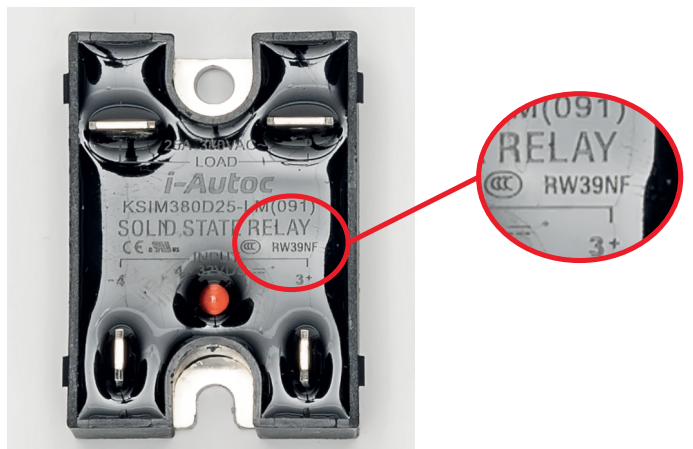
Figure 2: Faulty production lot

Potentially faulty relays are from the production lots **RW39** and **RX14**. The last two characters (NF in the example) are insignificant, see illustration above.

- ▶ Check the spare parts stock for the presence of solid-state relays with production codes **RW39** or **RX14**.
- ▶ Sort out solid-state relays with production code **RW39** and **RX14**.
- ▶ Machines in stock: Check machines in stock before or during installation.
