Type <b>Coffee Vending Machine</b>	Model <b>9200 CV – 9100 IN</b>	N° T.I. <b>09 - 2018</b>
Serial Number <b>See page 2/2</b>	Subject <b>CHANGE of HEATING ELEMENT ASSEMBLY SEQUENCE</b>	ISSUED FOR (X)
		Action Information <b>X</b>

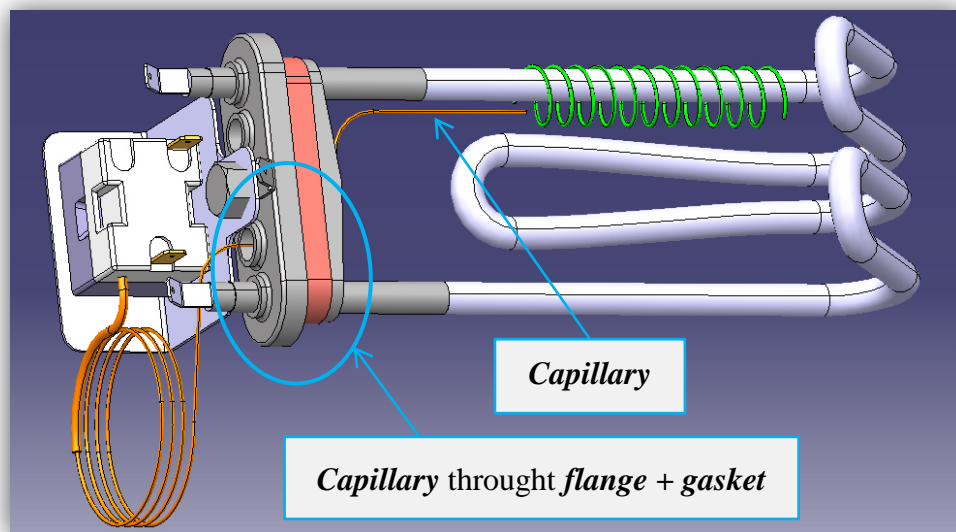
1. the capillary is now assembled through the *flange + gasket*

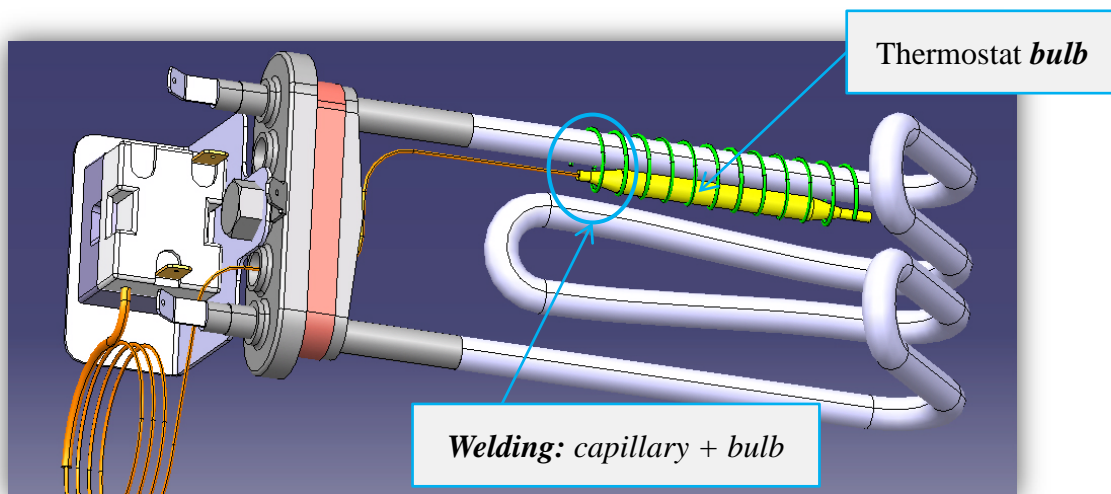
2. **weld** the thermostat *bulb* to the **capillary**
