<b>T.I. no.: 2019 - 02</b> Updated: -	<b>Topic: SCClub Software 1.6.4</b>
--	-------------------------------------

<b>Date: 24.01.2019</b>	<b>Priority</b>	<b>Need for action</b>
<b>Affected machines: SCClub</b>	High	As soon as possible
<b>From serial number: -</b>	Medium	On next visit to the machine
<b>As of date: -</b>	X Low	X FYI only

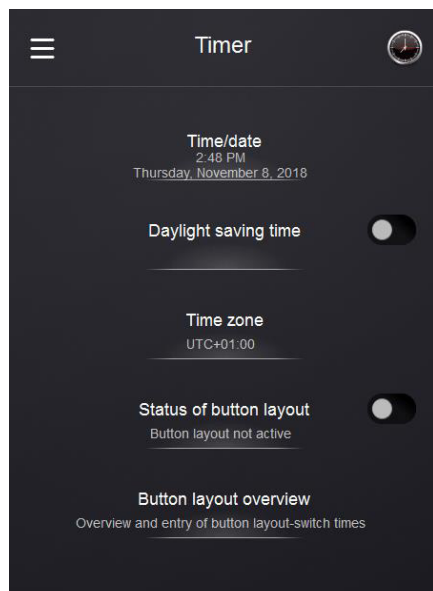
## Time zone and daylight saving time can be set

It is now possible to set the time zone and automatic changeover to daylight saving time.

The advantage of this is that the time on the coffee machine is automatically changed to daylight saving or winter time. The "Daylight saving time" setting is deactivated by default, meaning the automatic daylight saving/winter changeover is active.

The setting options are available both when commissioning new machines and later on using the Timer menu.

A machine with a built-in "CM-Gateway" telemetry module that is operated via the telemetry protocol NGx3 (CoffeeConnect), receives the time and date (UTC) via the NGx3 server (the menu option under Timer for the time/date setting is greyed out). The deviation from the server time is made by setting the time zone and daylight saving time.

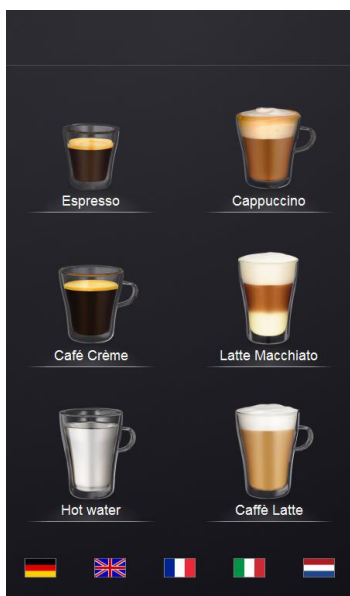
## "SS + flags" template optimised

Users have complained that, if a machine has configured with the "SS + flags" template, the beverage names for the beverage symbols at the bottom have been cut off by the display of the country flags, making them illegible.

With the new software, the beverage fields have been made smaller in this template and this means the beverage names are once again visible on the display.
