<b>T.I. no.:</b> 2019 - 31 <b>Updated:</b> -	<b>Topic:</b> SC Club – Change to cable routing for LED outlet lighting
---	---

<b>Date:</b> 12.12.2019	<b>Priority</b>	<b>Need for action</b>
<b>Affected machines:</b> SC Club	High	As soon as possible
<b>From serial number:</b> 18.385	X Medium	X On next visit to the machine
<b>As of date:</b> -	Low	FYI only

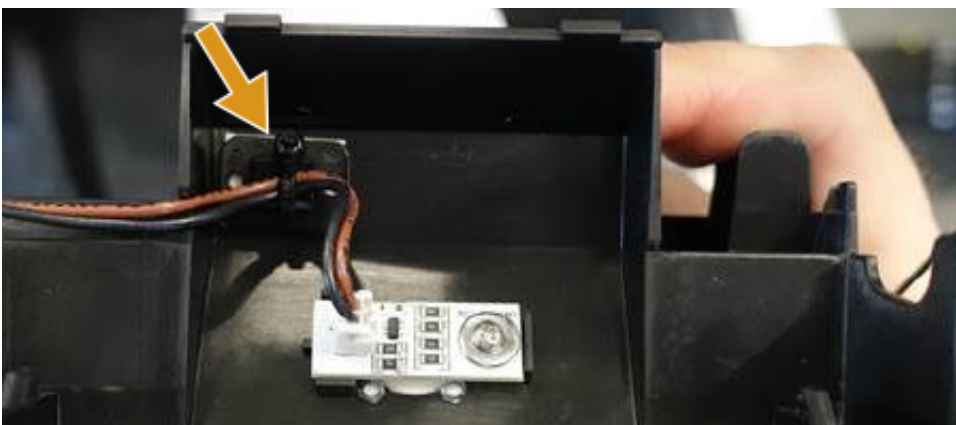
There have been isolated cases where the LED lighting has failed due to heat development in the connection plug, resulting in damage. The reason for the heat development is increased current consumption caused by moisture in the connection plug.

The cable routing has been changed in order to prevent moisture from travelling along the cable into the connection plug. The cable is now secured so that it runs to the connection plug in a curve. This routing prevents moisture from reaching the connection plug.

In order to prevent heat development as described above along with potential resulting damage, we recommend re-routing the cable for the LED lighting on your next scheduled customer visit. The cable should be secured with an additional cable fastening and cable tie so that it runs in a curve to the connection plug.

- 1x 33.4276.9000 Cable fastening
- 1x 33.0649.3000 Cable tie
