T.I. no.: 2020 - 17 Updated: -	Topic: Product optimisation of connector plug
---	--

Datum: 05.06.2020	Priority	Need for action
Betroffene Maschinen: Schaerer Barista	High	As soon as possible
As of date: Production 10.2016 (subsequent information)	X Medium	X On next visit to the machine
	Low	FYI only

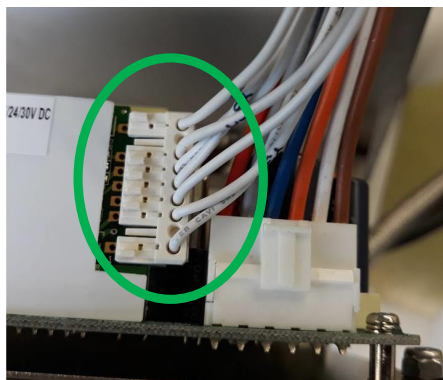
Correct plug-in position

Therefore, on machines with a production date up to 09.2016, it is absolutely important that you pay attention to the correct plug-in position when plugging in the 7-pin plug again on the switching power supply:

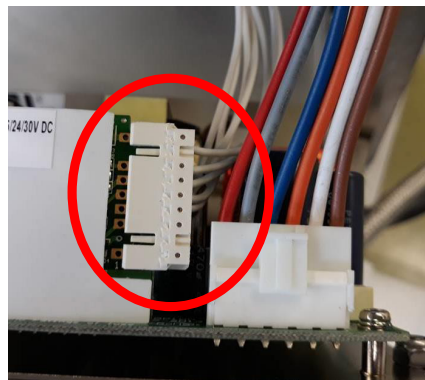
The 7-pin connector plug, which is plugged into the switching power supply at slot X 3, did not have a plug-in coding before the optimisation and can therefore be plugged in incorrectly on machines with a production date up to 09.2016. In this case the front panel of the machine is permanently damaged upon switch-on and the machine displays the error messages 9478 and 9479.

Incorrect plug-in position
