T.I. No.: 2021-01 Updated: -	Topic: SC Club Software Version 1.9.5
--	--

Date: 15.02.2021	Priority	Need for action
Affected machines: SC Club	High	As soon as possible
From serial number: -	X Medium	X On next visit to the machine
As of date: immediately	Low	FYI

The software version 1.9.5 is released for machines with a vending unit.

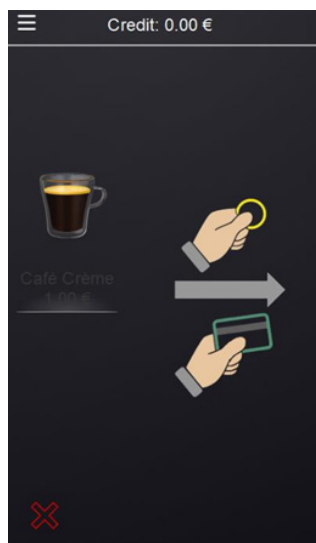
Tap&Go – Extension of functionality

After the beverage selection, the selected beverage is displayed with the price and credit, as well as the required action that is to be carried out (e.g. present card). The option of returning to the beverage selection is new.

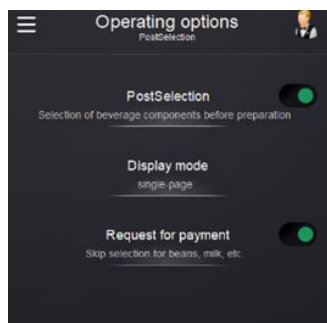
- Option „Request for payment“ activated:

The well-known PostSelection process with the possibility to select the bean type / beverage size etc. is skipped for all beverages and only the beverage selection + request for payment is always displayed.
