T.I. No.: 2021-02 Updated: -	Topic: Schaerer Barista - Software-Version 2.4.2
---	---

Date: 16.02.2021	Priority	Need for action
Affected machines: Schaerer Barista	High	As soon as possible
From serial number: -	X Medium	X On next visit to the machine
As of date: immediately	Low	FYI

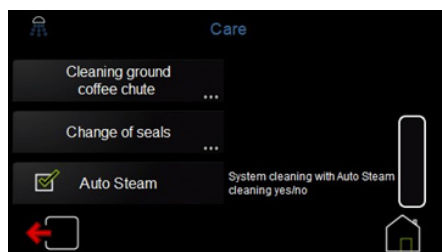
Care > Auto Steam

For machines with 2 Auto Steam wands, a new cleaning routine has been implemented. If this cleaning routine is activated in the care menu, a display-guided cleaning of the two Auto Steam wands is carried out prior to each machine cleaning. During this cleaning, the operator is prompted to clean the nozzle openings on both Auto Steam wands manually with a brush and to immerse the Auto Steam wands in a container with milk system cleaner. In the next step, the usual machine cleaning then starts. The Auto Steam cleaning function is deactivated by default.

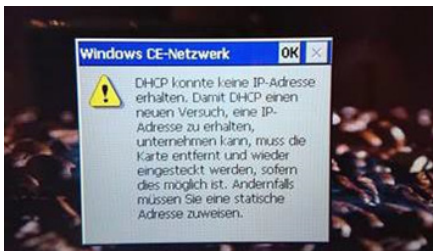
Error message - DHCP could not receive an IP address

If a machine was operated with a CM gateway, it occasionally caused a network error during switch-on of the machine. The machine could not receive an IP address and displayed the error message as shown on the right.

The error has been corrected with the new software version.
