<b>T.I. no.: 2021-14</b> Updated: 23.04.2021	<b>Topic: Temporary Change of Grinding Disks</b>
---	--

<b>Date: 23.04.2021</b>	<b>Priority</b>	<b>Need for action</b>
<b>Affected machines: SC Club</b>	High	As soon as possible
<b>From serial number: 49631</b>	X Medium	X On next visit to the machine
<b>As of date: immediately</b>	Low	FYI only

## IN-HOUSE MANUFACTURED GRINDING DISKS

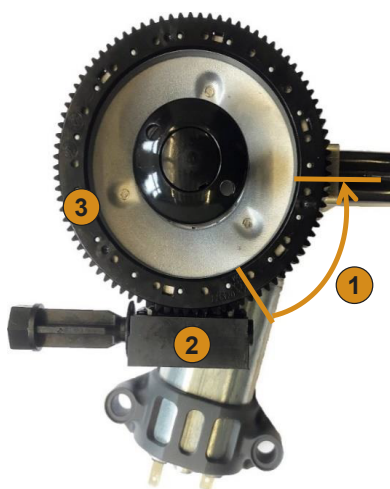
Open upper grinding disk (3) from marked block position (2) 13.5 teeth (1).

Open upper grinding disk (3) from marked block position (2) 19.5 teeth (1).
