T.I. no.: 2021-15 Updated:	Topic: Product Optimisation Rear Cover
---	---

Date: 27.05.2021	Priority	Need for action
Affected machines: SC Club	High	As soon as possible
From serial number: 50527	X Medium	X On next visit to the machine
As of date: immediately	Low	FYI only

PRODUCT OPTIMISATION REAR COVER

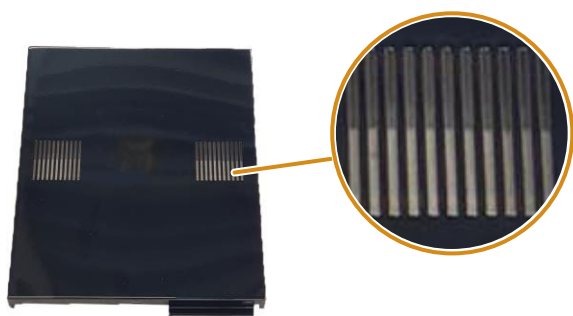
It has been found that under certain circumstances moisture may form in the machine interior due to condensation.

One reason for the formation of moisture is that when several beverages with a large volume (e.g. hot water 300 ml) are dispensed one after the other, the steam produced during this process is drawn into the machine interior via the ventilator and cannot be removed from the machine interior fast enough.

4 ventilation slots have additionally been added and the width of the ventilation slots has been increased.

In order to improve the air conditioning in the machine interior, with this product optimisation the ventilation slots of the rear cover have now been changed.

New – per field:

- 11 ventilation slots
- 2,8 mm width per slot
