T.I. No.: 2021-20 Updated: -	Topic: Schaerer Barista - Software-Version 2.4.3
--	---

Date: 02.07.2021	Priority	Need for action
Affected machines: Schaerer Barista	High	As soon as possible
From serial number: -	X Medium	X On next visit to the machine
As of date: immediately	Low	FYI

REASON FOR CHANGES COMPARED TO VERSION 2.4.2

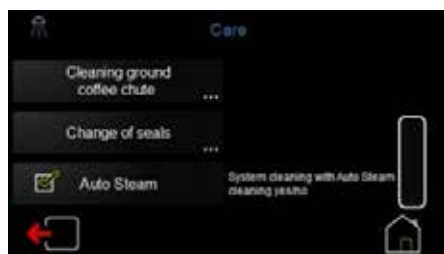
Care > Auto Steam

For machines with 2 Auto Steam wands, a new cleaning routine has been implemented. If this cleaning routine is activated in the care menu, a display-guided cleaning of the two Auto Steam wands is carried out prior to each machine cleaning. During this cleaning, the operator is prompted to clean the nozzle openings on both Auto Steam wands manually with a brush and to immerse the Auto Steam wands in a container with milk system cleaner. In the next step, the usual machine cleaning then starts. The Auto Steam cleaning function is deactivated by default.

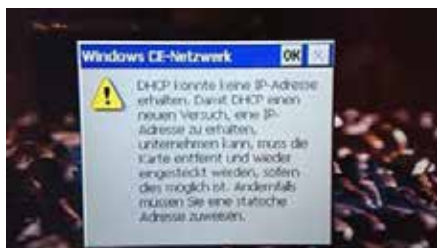
Error message - DHCP could not receive an IP address

If a machine was operated with a CM gateway, it occasionally caused a network error during switch-on of the machine. The machine could not receive an IP address and displayed the error message as shown on the right.

The error has been corrected with the new software version.
