T.I. no.: 2021 - 24 Updated: -	Topic: New brewer motor bracket (New kit)
---	--

Date: 30.08.2021	Priority	Need for action
Affected machines: SCS / SOUL	High	As soon as possible
From serial number: -	Medium	On next visit to the machine
As of date: -	x Low	x FYI only

ADVICE FOR TECHNICIANS

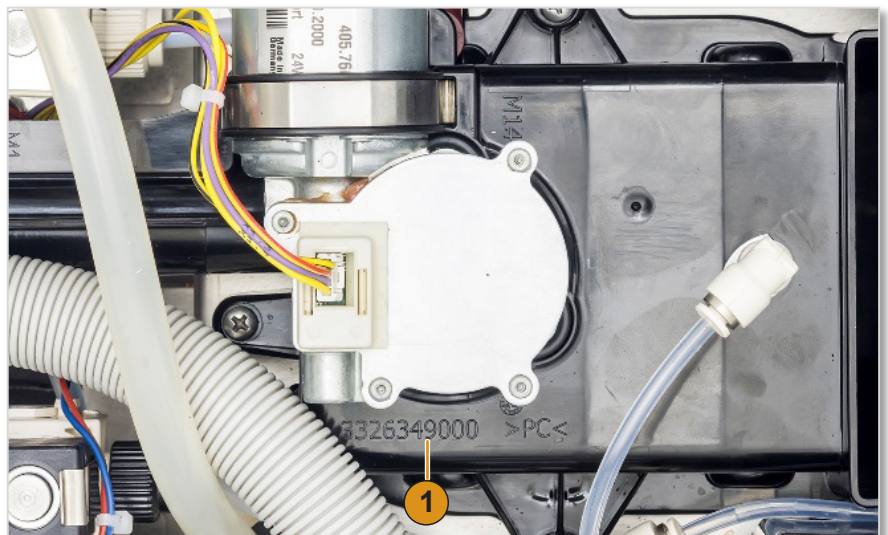
From CW03/2020 a new brewer motor bracket has been introduced:

For recognition see article number on the polycarbonate part:

- Previous article number (1)
- New article number (2).

Until ±CW52/2019: 33.2634.9000 > reworked to 079742 for use in the Soul

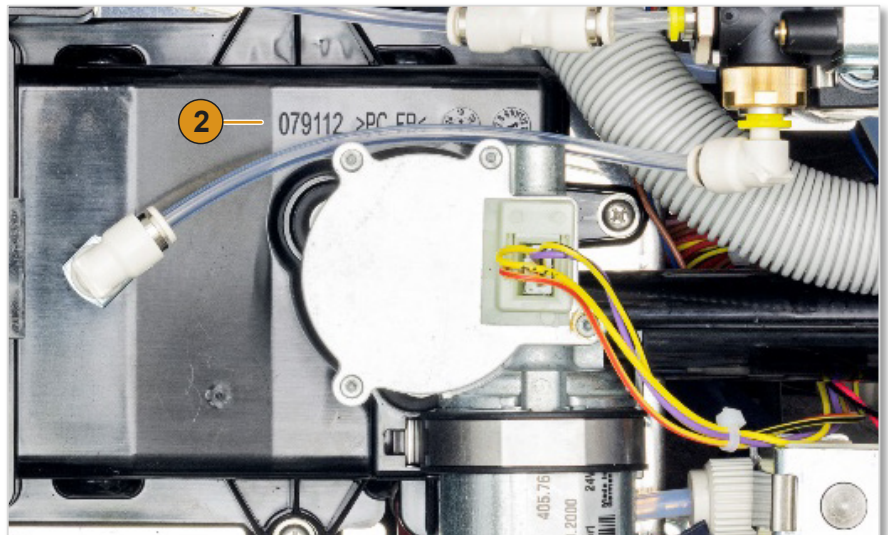
The new bracket 079112 has the following advantages:

- Substantially stronger reinforcements around the motor.
- Brewer motor can be removed (from the top) while the bracket remains in place.

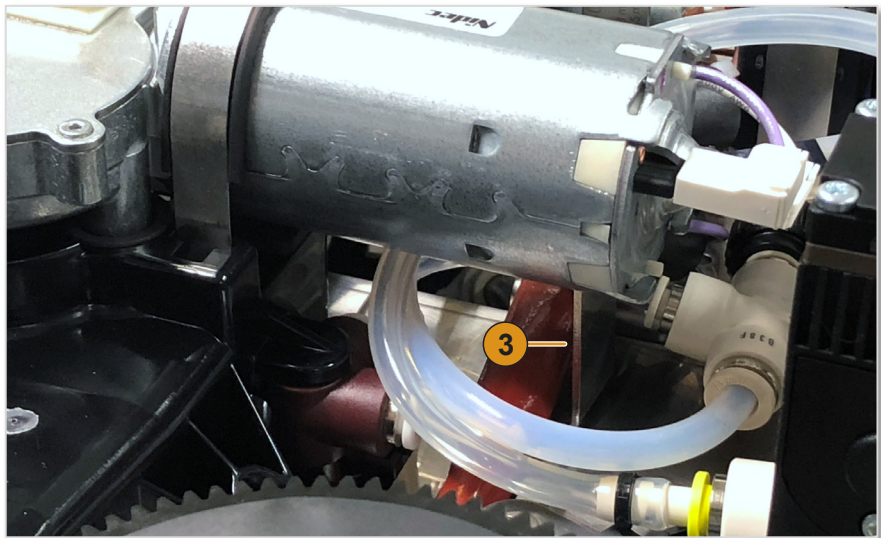
Currently a separate angled metal support is placed under the brewer motor (3).

Without this metal support it is possible that, when placing the brewer back into the machine, the motor is tilted making this process impossible.

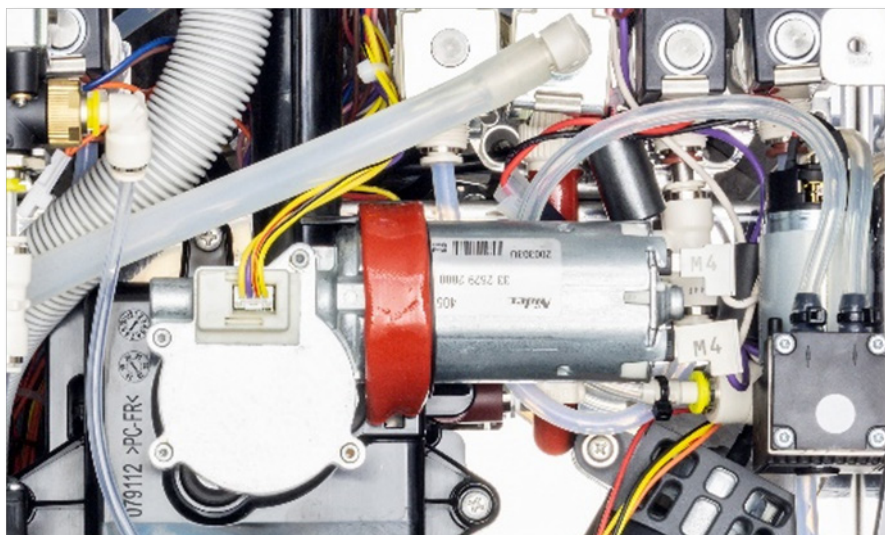
The Feedback from the field informed about the possibility that the fixation of the motor can become too loose over time.

This will result in the brewer motor to be pushed upwards while trying to place the brewing unit back after removal.

The issue can potentially happen with machines produced between Jan 13th, 2020 and Oct 14, 2020.

The solution is to place 110 mm of isolation sleeve 065259 over the metal clamp 33.2635.9000 as can be viewed in the picture. This solution has been implemented in the production of all machines from October 15th, 2020.
