T.I. no.: 2021-29 Updated: -	Topic: SC Club Software Version 2.2.3
---	--

Date: 28.10.2021	Priority	Need for action
Affected machines: SC Club	High	As soon as possible
From serial number: -	X Medium	X On next visit to the machine
As of date: Immediately	Low	FYI only

SOFTWARE RELEASE NOTE

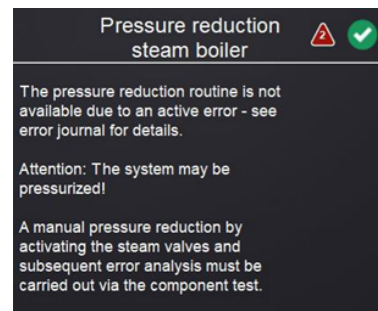
Pressure reduction routine – new advice text

With the new software version, a new advice text has been implemented for the pressure reduction routine.

This is displayed if the pressure reduction routine is not available due to an active error.

Here, it is indicated to switch to the component test in order to reduce the existing steam pressure via a steam valve, if necessary.
