<b>T.I. no.:</b> 2022-12 <b>Updated:</b> -	<b>Topic:</b> SCClub Software Version 2.3.2
---	---

<b>Date:</b> 12.04.2022	<b>Priority</b>	<b>Need for action</b>
<b>Affected machines:</b> SCClub	High	As soon as possible
<b>From serial number:</b> -	X Medium	X On next visit to the machine
<b>As of date:</b> Immediately	Low	FYI only

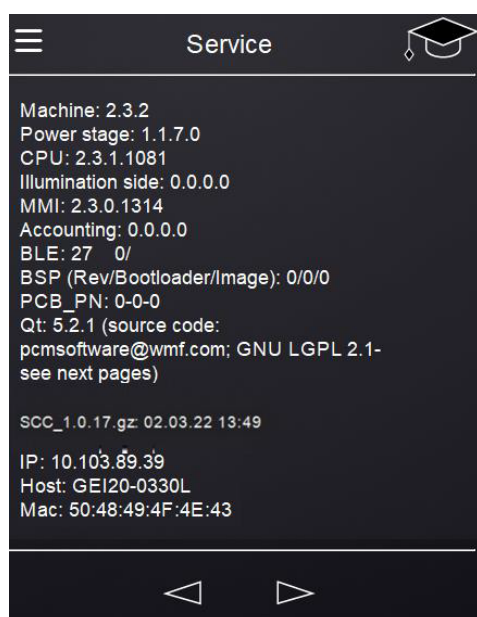
### Version display in the info menu (gz file)

If machines in the field are operated with special "gz files" (upload via language), so far the "gz file" used or the version could not be requested via the info menu.

With the new version, it can now be found out in the info menu whether a machine is operated with a "gz file" and the version of the "gz file" can be seen.

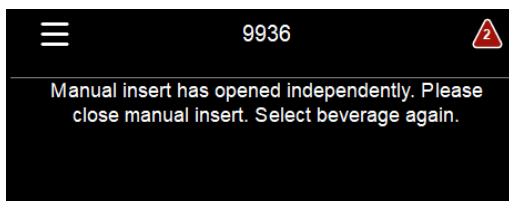
## Message 9936 added

If during a warm rinse or system cleaning the manual insert was opened by accident, only the error number 936 was displayed to the operator without any further error description or handling instructions.

With the new software version, this has been corrected and the information text for error number 936 is also displayed.
