T.I. no.: 2023-01 Updated: -	Topic: SCClub Software Version 2.4.2
---	---

Date: 25.01.2023	Priority	Need for action
Affected machines: SCClub	High	As soon as possible
From serial number: -	X Medium	X On next visit to the machine
As of date: Immediately	Low	FYI only

Technician info

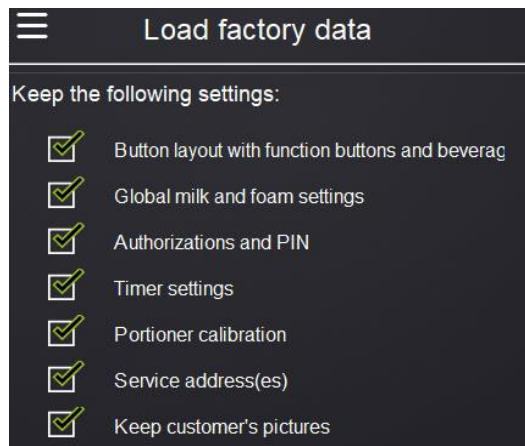
Changed standard values for machines with in-house manufactured grinding discs

The grinding discs on the SCClub have been changed from Itamill to grinding discs manufactured in-house.

Due to the higher charge capacity of the grinding discs the software standard parameters had to be adjusted. These new standard values are firmly saved in the factory data and thus have an effect on the function „Factory -> Service/Customer“.

If the portioner calibration data (Pic. 1) is not kept (deactivated) during loading the factory data, it is generally recommended to carry out a portioner calibration after the upload of the factory data.

This is even more important due to the use of different grinding discs in the field, as otherwise the charge capacities of the grinder may differ considerably.

Service > calibration **Service routines >** **Portioner**

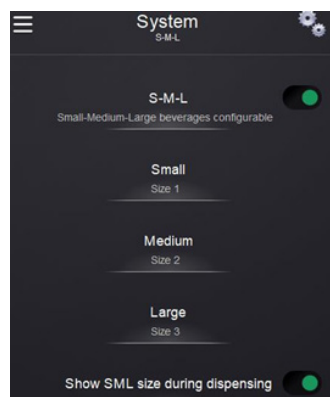
Display of selected beverage size in progress display

With the new software version the selected beverage size can now also be displayed in the progress display – if SML option is active.

System > S-M-L > show SML size during dispensing

The displayed texts for the beverage sizes correspond to the names entered in the menu System > S-M-L > Small / Medium / Large.
