T.I. no.: 2023-01 Updated: -	Topic: SCClub Software Version 2.4.3
---	---

Date: 25.01.2023	Priority	Need for action
Affected machines: SCClub	x High	x As soon as possible
From serial number: -	Medium	On next visit to the machine
As of date: Immediately	Low	FYI only

Technician info

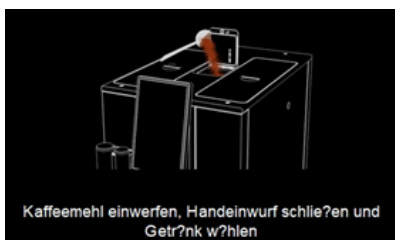
Error messages will be shown in the set language

After the software version 2.4.2 has been distributed to the field with Tech info 2023-01, we received messages in which it was described that all error and event messages – independent of the set language – were displayed in German.

In addition, the messages were displayed with wrong characters.

With this software version both errors were corrected.
