<b>T.I. no.:</b> 2023-15 <b>Updated:</b> -	<b>Topic:</b> Connecting screws on grinder motor
---	--

<b>Date:</b> 28.06.2023	<b>Priority</b>	<b>Need for action</b>
<b>Affected machines:</b> SCS/SOUL	High	As soon as possible
<b>From serial number:</b> -	x Medium	x On next visit to the machine
<b>As of date:</b> Immediately	Low	FYI only

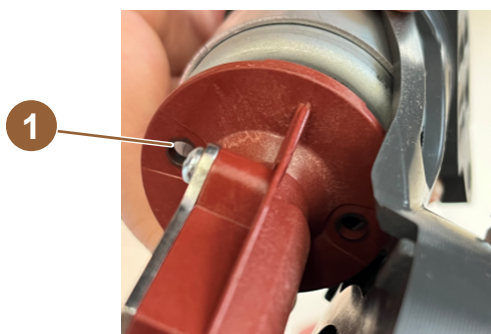
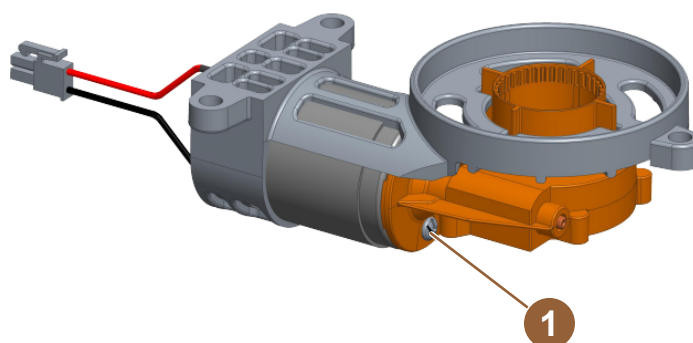
Due to grinder failure, a machine service (warranty service) was carried out and a missing screw lock between the grinder motor and the gearbox housing was detected. In certain cases, the screws of the grinding motor can loosen and, in the worst case, fall into the machine.

The next time you visit the coffee machine, check the connecting screws (1):

- check for tightness, tighten loose screws with 1-1.5 N.
- if screws are missing, use replacement screws (with article number 1204080).
