T.I. no.: 2023-26 Updated: -	Topic: SCA NA - Overheating of boiler relays
---------------------------------	--

### Boiler overheating due to relay switching too late

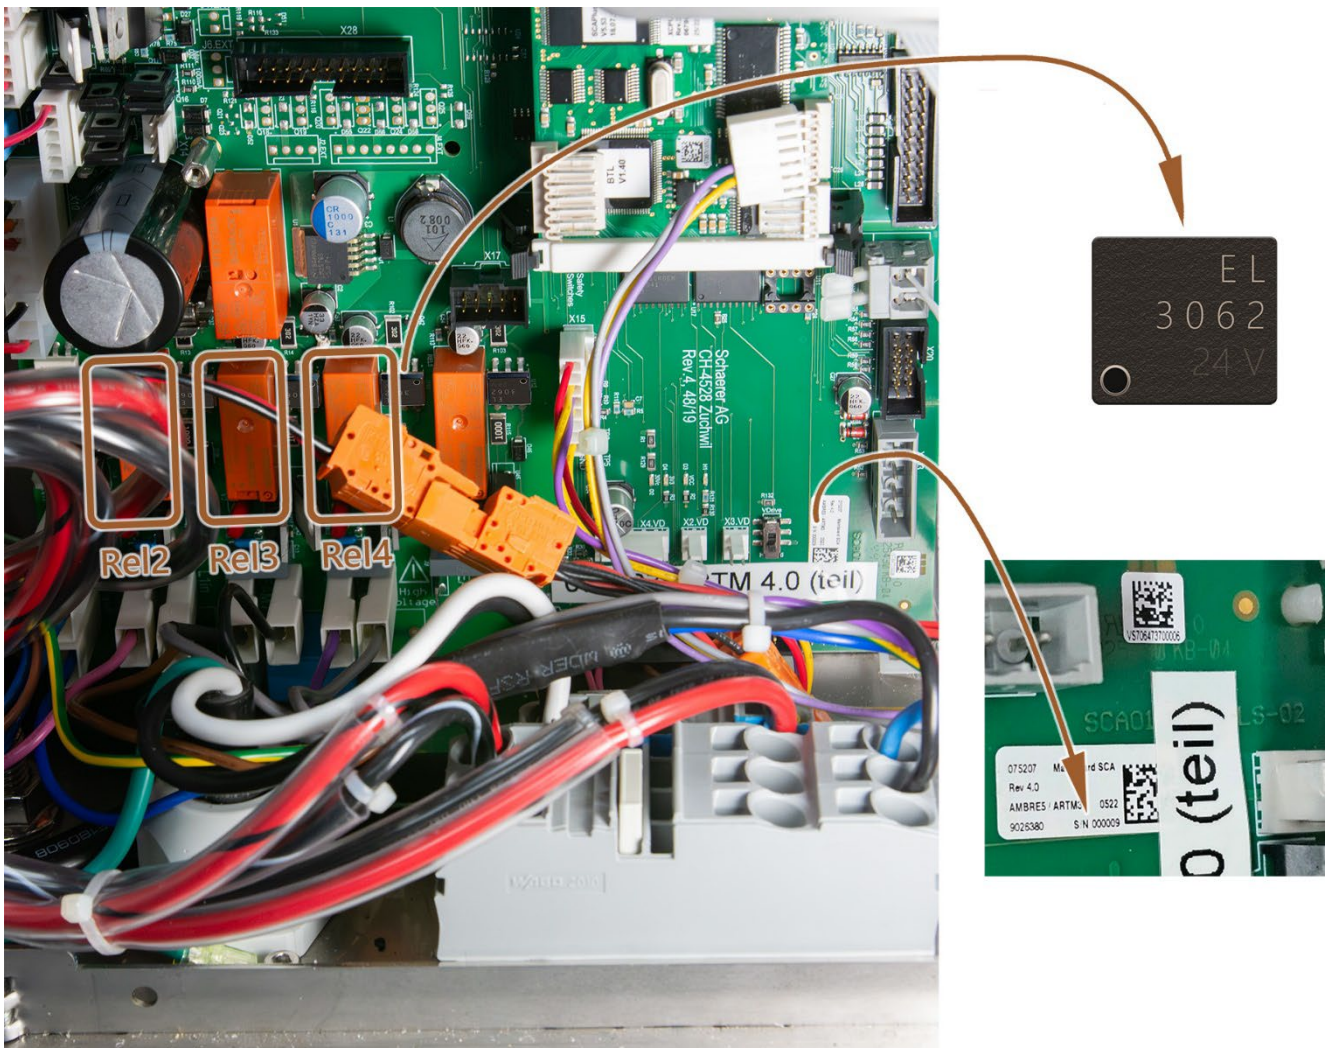
An opto-triac [EL 3062] from a second supplier, whose switching tolerance is somewhat higher than that of the first supplier, was used on the 075207 PC board on 580 machines between CW 42/2022 and 45/2022. This can cause opto-triacs U4, U5, U10 to switch downstream relays Rel2, Rel3, Rel4 with a delay. U12 and U41 are not affected.

This leads to light arcs between the relay contacts and to destruction of the relays; the downstream boilers are also activated for a period that is marginally too long. The heating elements overshoot and the safety thermostats trip.

### Distinguishing features: Serial number of the control PC board and type designation of the EL 3062 opto-triac

Figure 1: Identification of the serial number, part number 075207 (partially assembled)

- ▶ Check the component identification number (EL 3062) of the opto-triacs.
- ▶ Check whether the serial number of the PC board is in the range of 007902 – 008491. The number is not easy to identify. Use the magnifying glass function on your smartphone if possible.
- ▶ Replace the power board. Spare part 075208 PC board SCA ARTM 4.0 fully assembled.

Not all opto-triacs from the second supplier are outside the required tolerance. We expect a total of 20% of the affected batch. The power board must always be replaced if one or more relays are damaged.
