<b>T.I. no.:</b> 2023-28 <b>Updated:</b> -	<b>Topic:</b> Product optimisation suction chambers
---	---

<b>Date:</b> 07/12/23	<b>Priority</b>	<b>Need for action</b>
<b>Affected machines:</b> Schaerer Coffee Club	<input type="checkbox"/> High	<input type="checkbox"/> As soon as possible
<b>From serial number:</b> 82838	<input checked="" type="checkbox"/> Medium	<input checked="" type="checkbox"/> On next visit to the machine
<b>Start date:</b> immediately	<input type="checkbox"/> Low	<input type="checkbox"/> FYI only

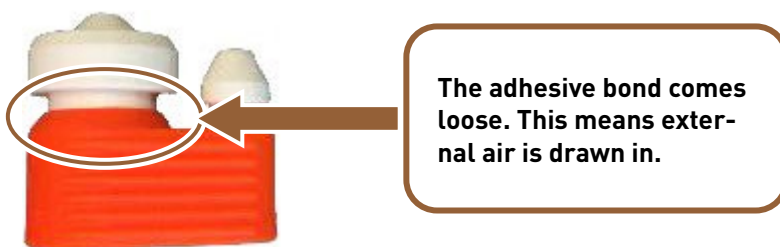
There are reports from users about problems with the milk being sucked out of the milk container/cooler. Investigations of the suction chambers subject to complaint revealed that the adhesive bond between the coloured elastomer element and the white nozzle insert came loose and external air was drawn in.

Figure 1: Adhesive bond between nozzle insert and elastomer element

A metal clip is attached to the suction chambers to reinforce the adhesive bond. The metal clip prevents the elastomer element from coming loose from the white nozzle insert. The suction chamber can easily be exchanged by the customer. The replacement is described in the operating instructions.

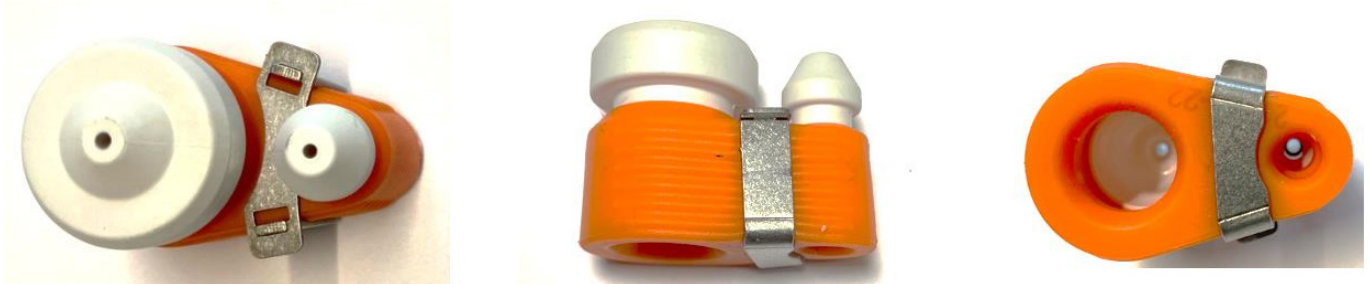
Figure 2: Metal clip taking the example of an orange suction chamber
