T.I. no.: 2024-19 Updated: -	Topic: Software version 2.6.1
----------------------------------------	--------------------------------------

Date: 12/2/2024	Priority and need for action <input type="checkbox"/> High: as soon as possible <input checked="" type="checkbox"/> Medium: on next visit to the machine <input type="checkbox"/> Low: FYI only
Affected machines: CLUB	
From serial number: -	
From date: right away

INFORMATION ON BSP 45 AND NEW SOFTWARE VERSION 2.6.1

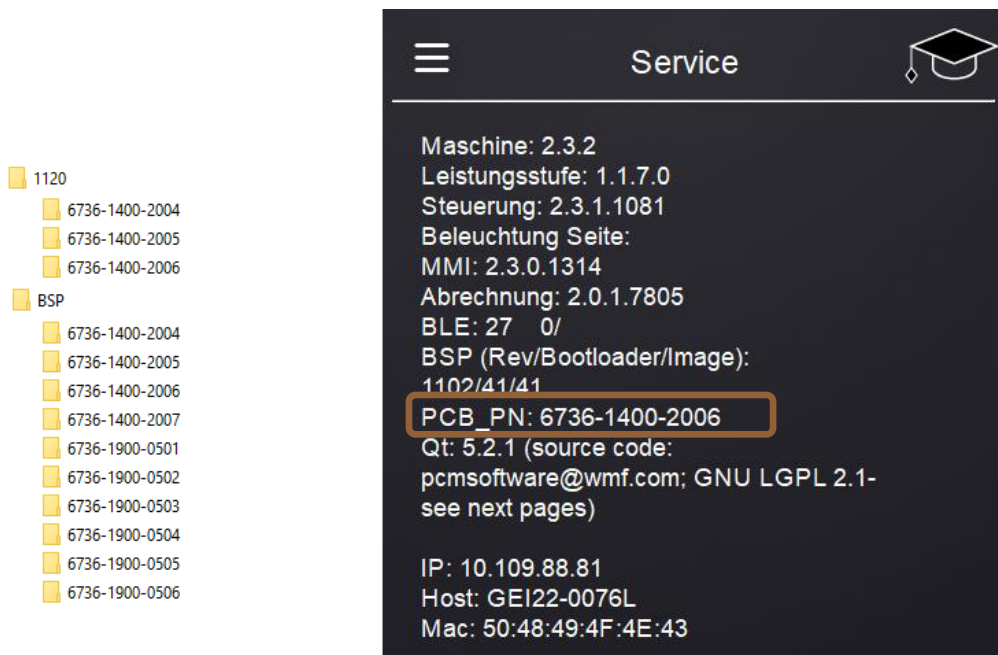
Figure 1: Folder structure on USB data carrier and hardware version

Firmware version **BSP_45.exe** does not support all hardware versions of the front panels in the field. The affected machines do not recognize the BSP version on the USB stick, which is why the BSP update routine does not start. That is why BSP versions older than **BSP_45_new.exe** cause an error message.

Each subfolder corresponds to a hardware version (PCB_PN) and is displayed in the **Info** menu.

The **BSP_45_new.exe** file is available for download in the Media Pool. The **BSP_45_new.exe** does not support all hardware versions in the field. We recommend deleting the previously saved **BSP_45.exe** versions from the USB data carriers and the computers and replacing them with the new **BSP_45_new.exe** (Media Pool).

After **BSP_45_new.exe** is extracted, the following folders must be created on the USB data carrier:

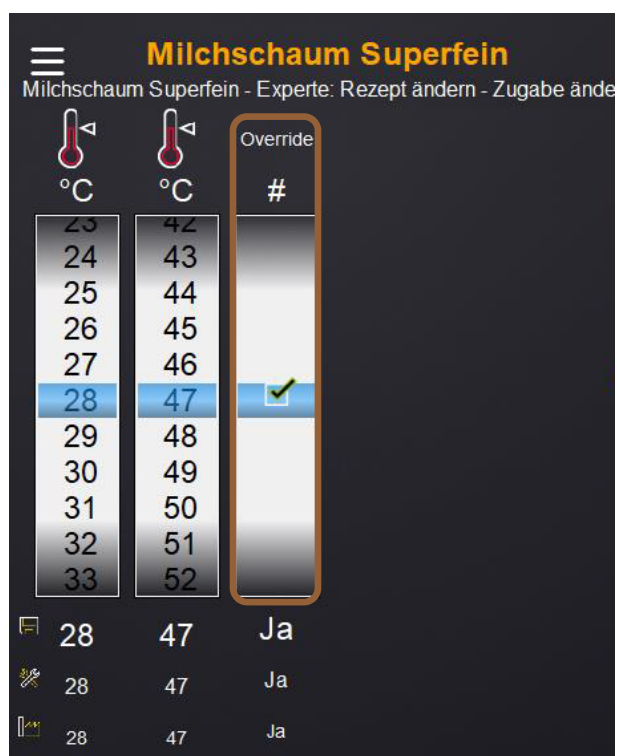
Figure 5: Override function activated

The **SuperSteam** override function did not work with earlier software versions.

Once the temperature set in the recipe had been reached, it was not possible to continue heating when the **SuperSteam** button was pressed.

This behavior is corrected in the new software version.
