T.I. no.: 2024-19 Updated: -	Topic: Software version 2.6.1
---	--------------------------------------

Date: 12/2/2024	Priority and need for action <input type="checkbox"/> High: as soon as possible <input checked="" type="checkbox"/> Medium: on next visit to the machine <input type="checkbox"/> Low: FYI only
Affected machines: CLUB	
From serial number: -	
From date: right away

INFORMATION ON BSP 45 AND NEW SOFTWARE VERSION 2.6.1

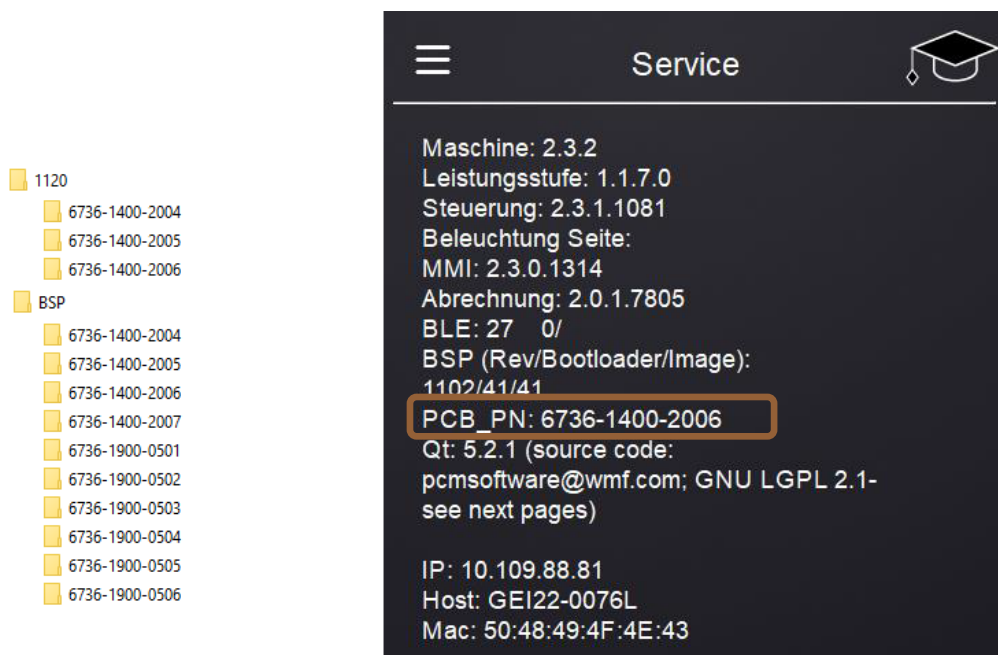
Figure 1: Folder structure on USB data carrier and hardware version

Firmware version **BSP_45.exe** does not support all hardware versions of the front panels in the field. The affected machines do not recognize the BSP version on the USB stick, which is why the BSP update routine does not start. That is why BSP versions older than **BSP_45_new.exe** cause an error message.

Each subfolder corresponds to a hardware version (PCB_PN) and is displayed in the **Info** menu.

Before the new **v2.6.1** software is installed for machines in the field, the software version of the operating system on the front panel must be checked during the next customer visit. If older BSP versions are in use, the **BSP_45_new.exe** version must be installed.

The **BSP_45_new.exe** file is available for download in the Media Pool. The **BSP_45_new.exe** does not support all hardware versions in the field. We recommend deleting the previously saved **BSP_45.exe** versions from the USB data carriers and the computers and replacing them with the new **BSP_45_new.exe** (Media Pool).

After **BSP_45_new.exe** is extracted, the following folders must be created on the USB data carrier:

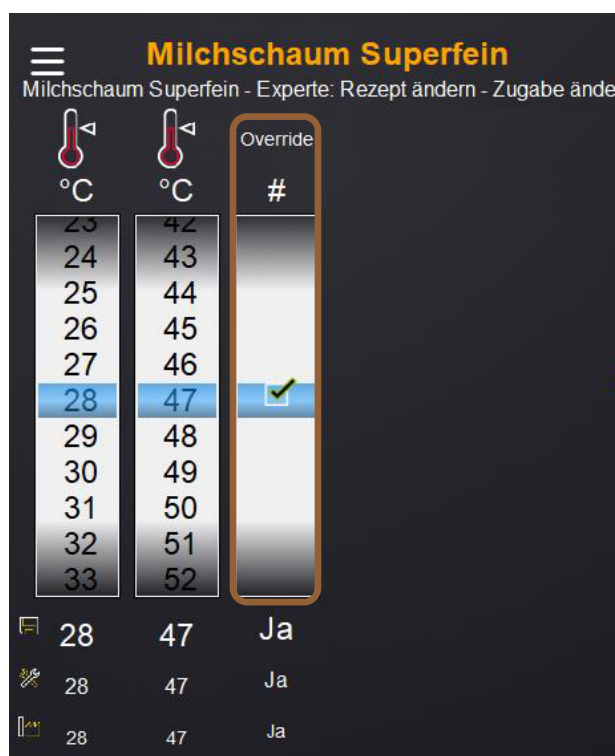
Figure 5: Override function activated

The **SuperSteam** override function did not work with earlier software versions.

Once the temperature set in the recipe had been reached, it was not possible to continue heating when the **SuperSteam** button was pressed.

This behavior is corrected in the new software version.
