<b>T.I. no.:</b> 2025-12 <b>Updated:</b> -	<b>Topic:</b> Leaky hot water outlet
---	--------------------------------------

<b>Date:</b> 2025-10-28
<b>Affected machines:</b> SOUL
<b>From production date:</b> 01-01-2025
<b>From date:</b> right away

## LEAKY HOT WATER OUTLET

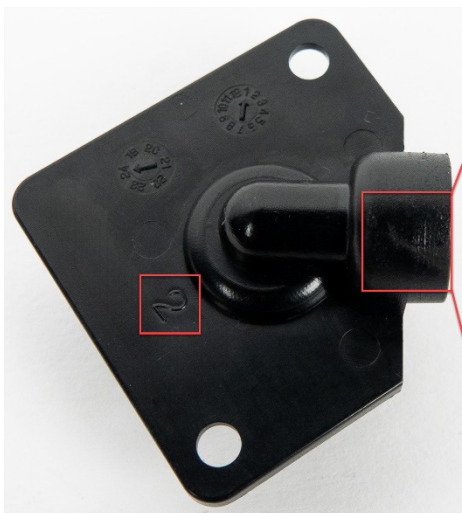
Figure 1: hot water outlet external

The 2 mark and the problematic fusion point can be seen on the A crack can be seen on the inside of the hot water outlet.

During a quality inspection, it became clear that some hot water outlets have product defects. This is due to a tooling error by the manufacturer, which resulted in the plastic material not being properly fused at one point. The defect only occurs in components marked with a 2. An unclear material fusion point is visible on the outside of the affected area and a crack is visible on the inside. Outlets that are tight during assembly will remain tight. Spare parts for machines with a production date between 2025-01-01 – 2025-03-01 can be ordered under warranty through the official channels.
