<b>T.I. no.:</b> 2025-12 <b>Updated:</b> -	<b>Topic:</b> Leaky hot water outlet
---	--------------------------------------

## LEAKY HOT WATER OUTLET

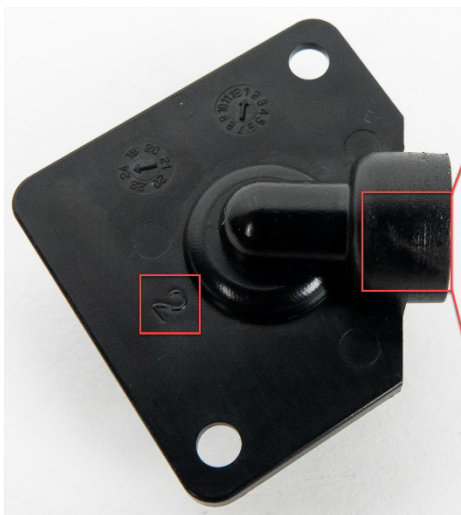
Figure 1: hot water outlet external

During a quality inspection, it became clear that some hot water outlets have product defects. This is due to a tooling error by the manufacturer, which resulted in the plastic material not being properly fused at one point. The defect only occurs in components marked with a 2. An unclear material fusion point is visible on the outside of the affected area and a crack is visible on the inside. Outlets that are tight during assembly will remain tight. Spare parts for machines with a production date between 2025-01-01 – 2025-03-01 can be ordered under warranty through the official channels.

The 2 mark and the problematic fusion point can be seen on the A crack can be seen on the inside of the hot water outlet.
