| T.I. no.: 2025-15 Updated: - | Topic: ABS buffer in grounds container shaft |

| Date: 2025-11-03 | Priority and need for action |
| Affected machines: SOUL 10/12 | |

NEW HOLDER FOR COMBINATION SENSOR AND NEW DEVICE BASE

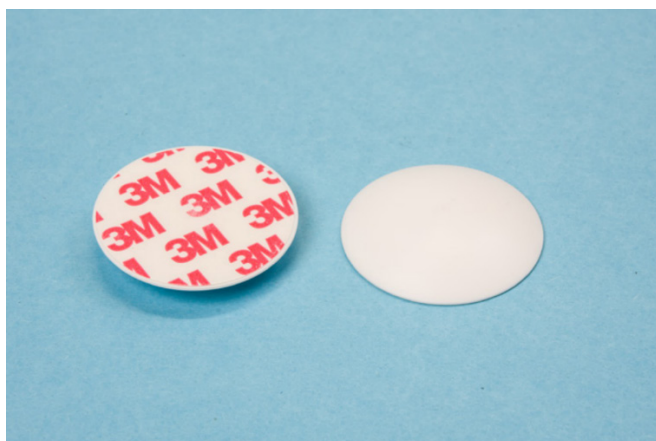
Figure 1: ABS buffer 3370074789

We are receiving an increasing amount of feedback that the grounds container is not detected correctly on some machines if it is positioned slightly too far to the right.

In this case, an ABS buffer (3370074789) must be attached to the rear right-hand side of the grounds container shaft. This pushes the grounds container slightly to the left so that it is correctly detected by the sensor.

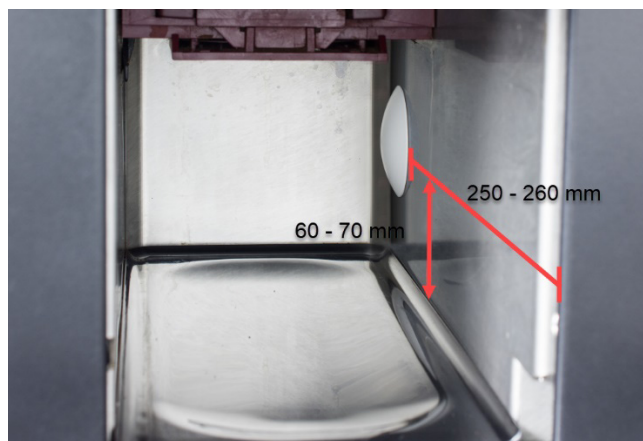
Figure 2: ABS buffer glued into the brewing shaft

- ▶ Clean the gluing point.
- ▶ Remove the protective film from the adhesive on the back and stick the buffer in the position shown.
