Info-2021-01-EN

## WMF 1100S Product Optimization Bean Hopper Extension 33.2917.4000

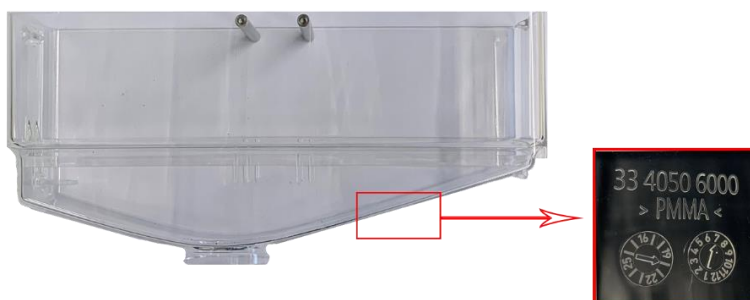
Position production stamp

The product optimization has already been introduced in series, retaining the item number and can be identified by means of the production date as of 7/20 according to the production stamp.
