SERVICE MEMO

Number: JDE 2024-02
Dispenser(s): Schaerer *Procare*
Title: Schaerer Procare drip tray sensor adjustment

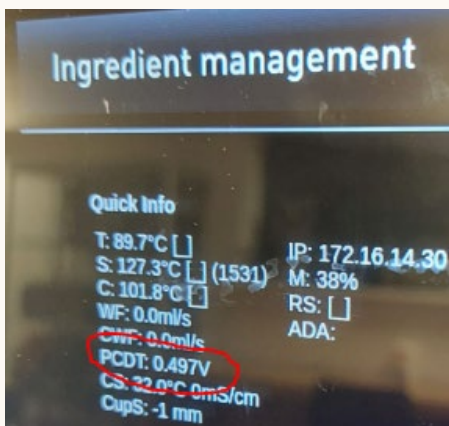
With this service memo I would like to inform you what to do if the drip tray sensor of the Procare unit give drip tray full or drip tray not in place after installation. We have seen a couple of Procare units with this problem and already informed Schaerer.

- Switch on the Quick Info in het menu in.
- Check the voltage after PCDT (see picture below), it should be between 500mV and 600mV.

- In case you have no screw driver with torc measurement you can tighten the screw with the empty drip tray inserted until the quick information displays the voltage between **500mV – 600 mV**.
