T.I. No.: 2023-18d Updated: 02/11/2023	Subject: Failure of the solid-state relay (update III)
--	---

Follow up defective solid-state relays

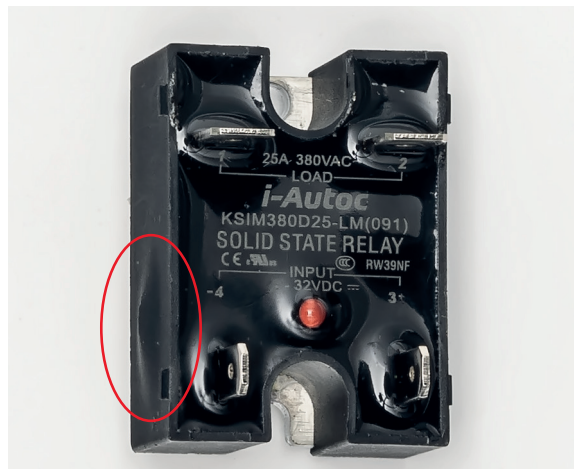
Figure 1: Solid-state relay, article no. 072044

A failed relay can look intact from the outside or burnt to varying degrees (see example picture). Often, one of the safety thermostats (Klixons) will trip. In isolated cases, the power board requires replacement.

- ▶ Check the production code of the solid-state relays.
- ▶ If the relays are from the **RW39** or **RX14** production lots: Replace all relays.

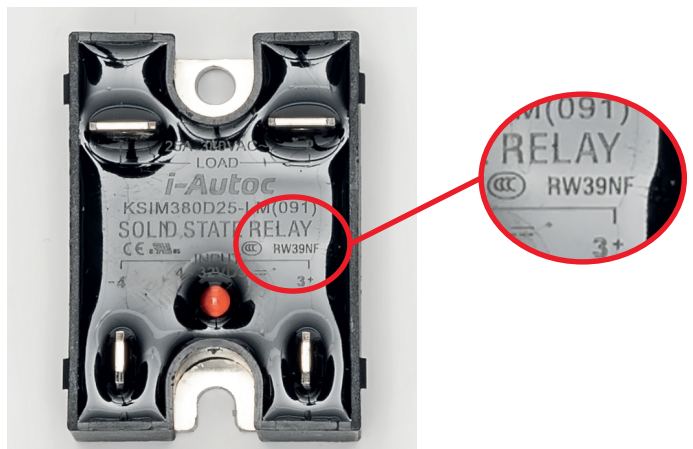
Figure 2: Faulty production lot

Potentially faulty relays are from the production lots **RW39** and **RX14**. The last two characters (NF in the example) are insignificant, see illustration above.

- ▶ Check the spare parts stock for the presence of solid-state relays with production codes **RW39** or **RX14**.
- ▶ Sort out solid-state relays with production code **RW39** and **RX14**.
- ▶ Machines in stock: Check machines in stock before or during installation.

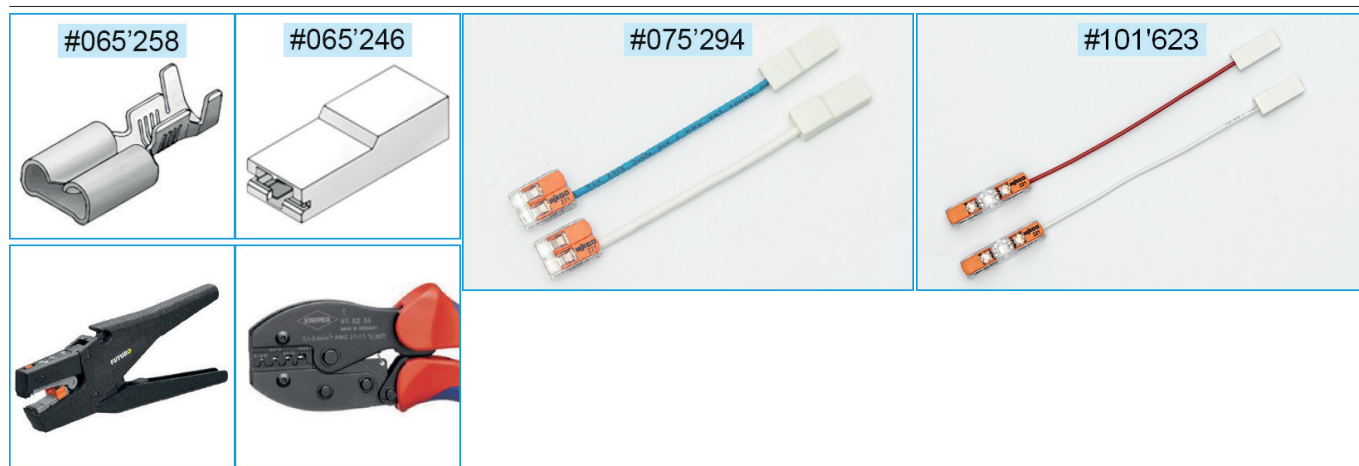
Figure 3: Connectors and tools

Connectors suitable for the **output** of the Solid State Relay (6.3 x 0.8 mm) can be ordered from Schaerer Ltd.

- Plug-in connector 6.3 x 0.8 mm for 1.5 - 2.5 mm² (steel-nickel plated): **#065'258**.
- Isolation sleeve (6.3 mm, Glow wire GWT compatible): **#065'246**.
- For those service organisations which do not have suitable tools or knowledge for an electrically safe repair may use boiler wiring repair kit **#075'294** (SSR **output side**) or the low voltage repair kit **#101'623** for the **input** of the solid-state relay (4.8 x 0.5 mm).
- ▶ Use suitable (professional) tools to mount the plug-in connections in an electrically safe manner (not sold by Schaerer Ltd).

Figure 4: Repair kit for output

Figure 5: Repair kit for input
