| T.I. no.: 2017 - 16 Updated: - | Topic: ABS buffer for side cooling unit |

ABS BUFFER (074789) FOR SIDE COOLING UNIT

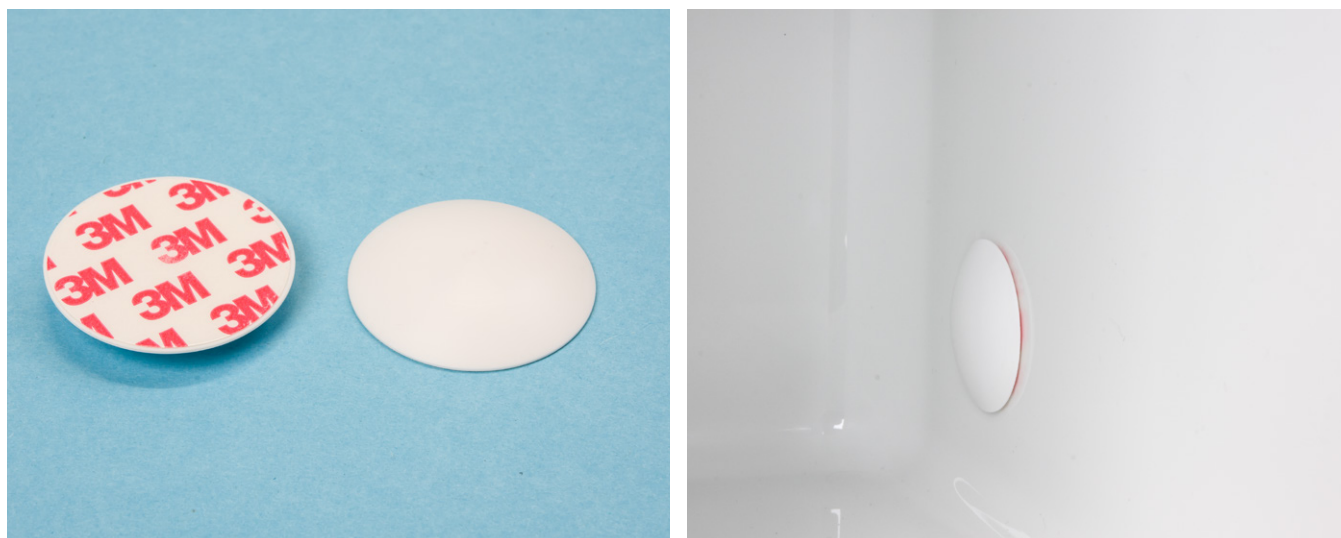
The milk level sensor does not work correctly in some side cooling units if the milk container is on the right side of the cooling unit.

In this case, the ABS buffer (074789) can be affixed to the right rear area of the side cooling unit. The milk container is then located farther to the left and is correctly detected by the sensor.

- ▶ Clean the adhesive surface.
- ▶ Pull the protective film of the adhesive from the rear side and affix the buffer.

In side cooling units from serial number 17250464, the sensor is reprogrammed to prevent this malfunction. The side cooling unit serial number is visible on the interior side.
