T.I. no.: 2019 - 10 Updated: -	Topic: Loose beverage outlet and user panel bracket screws
---	---

Date: 25.06.2019
Affected machines: SC Soul
From serial number: -
As of date: -

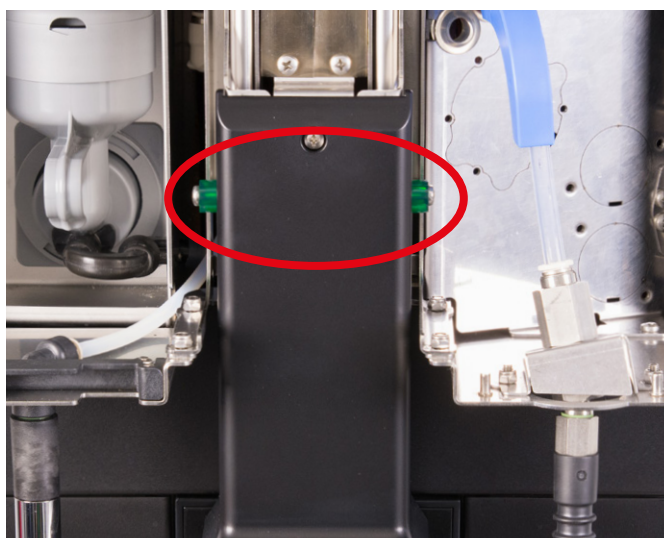
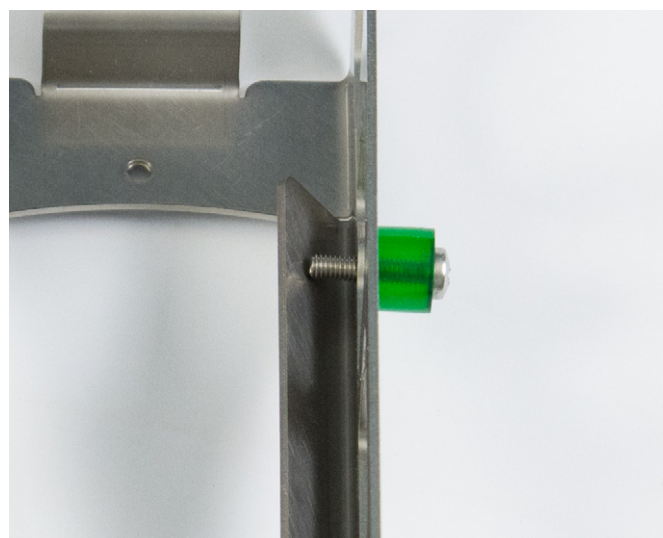
Beverage outlet bracket

Due to insufficient screw lock, screws can loosen at the sides of the beverage outlet and user panel brackets over time.

View of rear side with M4x18 (060543)

In affected machines, treat the long M4x18 (060543) screws with screw lock and tighten. The screws can be ordered for free from Schaerer AG until 31/12/2019.

The assembly process has been adapted. For machines starting with serial number 1921.../, the screws do not loosen.
