T.I. no.: 2019 - 28 Updated: -	Topic: Product optimisation: New milk hose – 00.0048.4939
--	--

Date: 11.12.2019	Priority	Need for action
Affected machines: SC Club	High	As soon as possible
From serial number: 21971 ff	X Medium	X On next visit to the machine
As of date: -	Low	FYI only

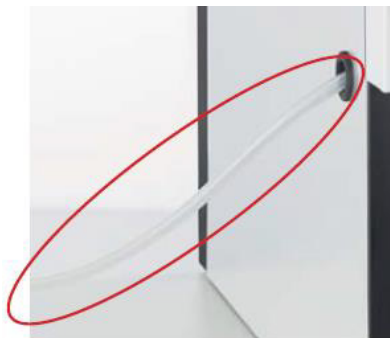
Art. no.: 00.0048.4948

Old: "Transparent" milk hose

The new hose is black-transparent rather than just transparent in order to prevent mix-ups. Old "transparent" hoses (art. no. 00.0048.4948) in the field should be replaced with the new "black-transparent" hose (art. no. 00.0048.4939) as soon as possible, at the latest by the next due date. The recommended interval for replacing the milk hose is 6 months; see operating instructions. The old "transparent" hoses must no longer be used on the SC Club after this point!

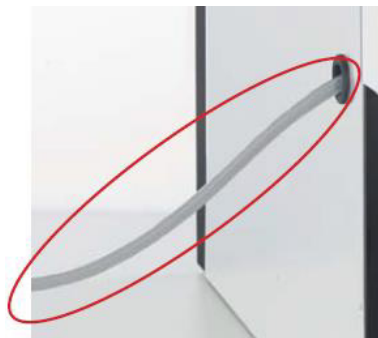
Art. no.: 00.0048.4939

New: "Black-transparent" milk hose

- New milk hose with spare part number **00.0048.4939** (silicone hose 4x2 black-transparent with 4 mm internal diameter / 2 mm wall) has been incorporated into series production with serial number **21971** of the SC Club.
- The increased wall thickness of the new milk hose makes it practically impossible for the hose to kink, significantly reducing the risk of backing up during Click & Clean cleaning.
