T.I. no.: 2020 - 10 Updated: -	Topic: Schaerer Barista product optimisation for bean hopper cover
-----------------------------------	--

Date: 20/3/2020	Priority	Need for action
Affected machines: Schaerer Barista	High	As soon as possible
From serial number: -	X Medium	X On next visit to the machine
As of date: Immediately	Low	FYI only

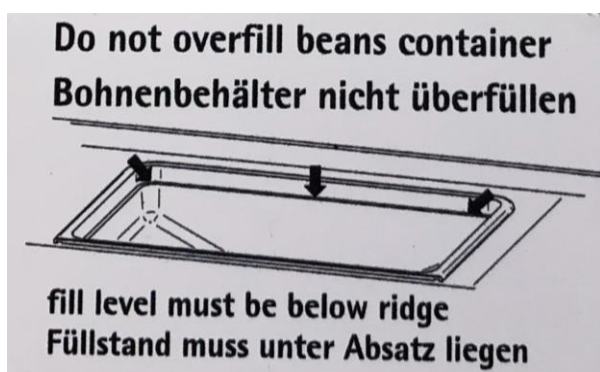
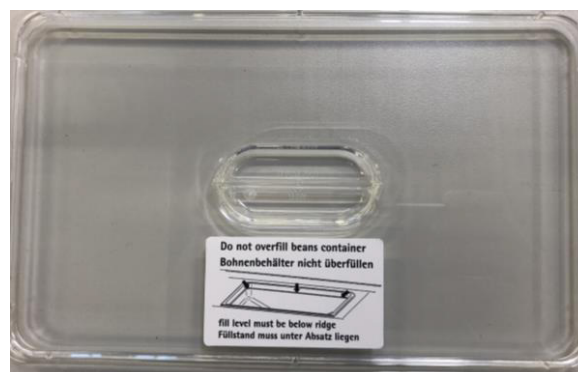
Position of the sticker:

There have been field reports stating that, when filling the bean hoppers, the maximum fill level is not observed. This means the covers can no longer be properly fit on the bean hoppers, causing them to protrude upwards. When closing the cup tray, the bean hopper covers get clamped and can break.

A sticker has been attached to the bean hopper covers to inform customers of the maximum fill level and prevent overfilling.

The sticker is available as a spare part and can be attached later by the customer if needed; 2 stickers are needed per machine.

Article number: 33.4352.1000
