T.I. no.: 2024-20 Updated: -	Topic: Replacement of “mint green” plug-in connections
---	---

DESCRIPTION OF THE PROBLEM

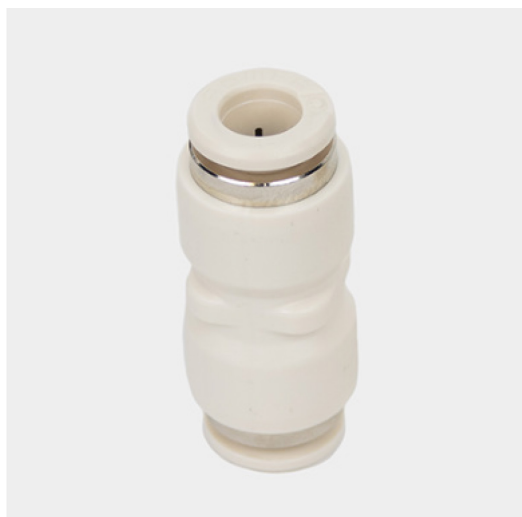
Figure 1: Standard plug-in connection with the cream white release ring

Although Schaerer was unable to detect any leaks during these extensive tests, a decision was made to return to the **cream white standard plug-in connections** to be on the safe side.

- ▶ Proactive replacement is not required for **Schaerer machines** in the field that are equipped with **mint green plug-in connections**.
- ▶ During regular maintenance, check the machines for leaks as usual.

- ▶ To avoid future installation of the **mint green plug-in connection** in all machines, we ask that you please return all **mint green plug-in connection** and replace them with the **cream white standard plug-in connections**.

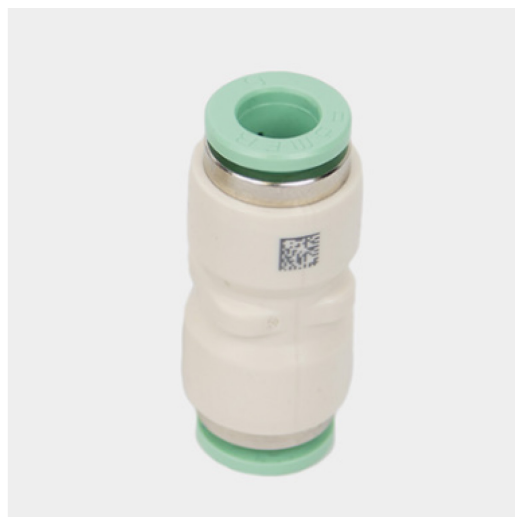
We have determined that the **plug-in connections** with the **mint green release ring** leak in certain applications. The machines of our sister company WMF are affected by leaks. The leaks are caused by the fact that WMF uses different hoses (PTFE) and metal connections with different geometries. (Technical Information forwarded from WMF, 2024-45 on 12/6/2024).

Figure 2: Plug-in connection with the mint green release ring (Hyperfit)
