<b>T.I. no.:</b> 2025-15 <b>Updated:</b> -	<b>Topic:</b> ABS buffer in grounds container shaft
---	---

<b>Date:</b> 2025-11-03
<b>Affected machines:</b> SOUL 10/12
<b>From production date:</b> 10-25-2025
<b>From date:</b> right away

## NEW HOLDER FOR COMBINATION SENSOR AND NEW DEVICE BASE

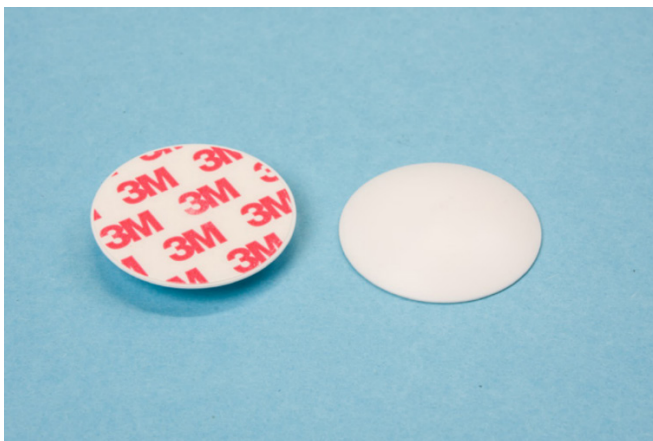
Figure 1: ABS buffer 3370074789

In this case, an ABS buffer (3370074789) must be attached to the rear right-hand side of the grounds container shaft. This pushes the grounds container slightly to the left so that it is correctly detected by the sensor.

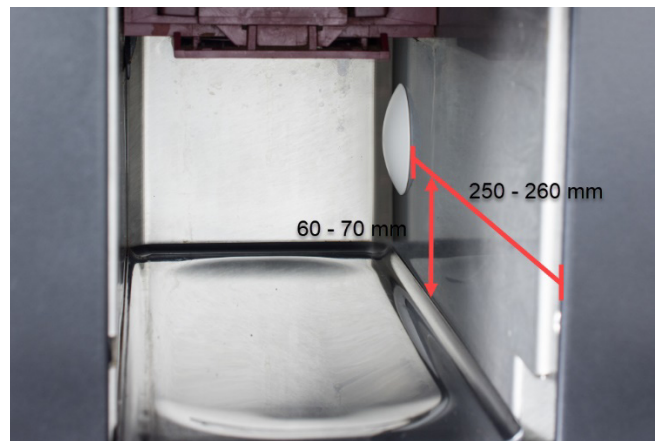
We are receiving an increasing amount of feedback that the grounds container is not detected correctly on some machines if it is positioned slightly too far to the right.

Figure 2: ABS buffer glued into the brewing shaft

- ▶ Clean the gluing point.
- ▶ Remove the protective film from the adhesive on the back and stick the buffer in the position shown.
