T.I. no.: 2017 - 10 Updated: -	Topic: SCA P Best Foam™ switching valve
---	--

Date: 19/7/2017
Affected machines: SCA P Best Foam™
From serial number: -
As of date: 1/4/2017

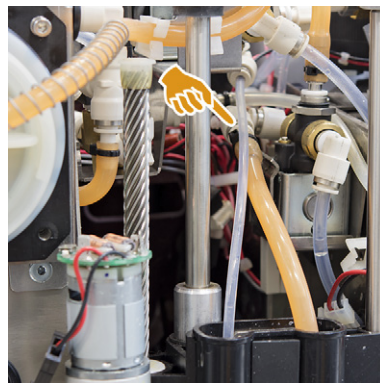
Installation of switching valve up to 1/3/2017

The switching valve including the holder was rotated by 180°. The cable connections from the cable harness to the switching valve are therefore too short. The cable harness has been adjusted accordingly.

For machines produced before 1/3/2017, the spare parts listed below must be ordered to replace the switching valve.

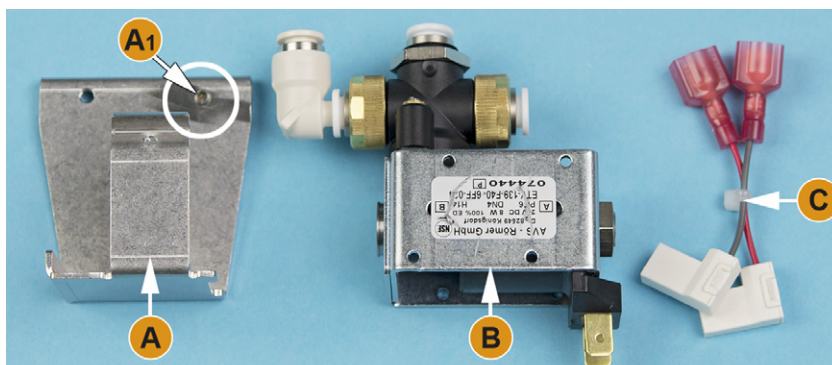
Spare parts for switching valve

- [A] 074412 Switching valve holder
- [A1] 1008022 Threaded pin screw M4x6
- [B] 074440 Switching valve
- [C] 072052 Extension cable

The following spare parts must be ordered for the replacement of the switching valve:
