T.I. no.: 2018 - 07 Updated: -	Topic: ABS buffer for grounds container
---	--

Date: 23.04.2018
Affected machines: SC Soul
From serial number: 1808.../
As of date: -

ABS BUFFER (074789) FOR GROUNDS CONTAINER

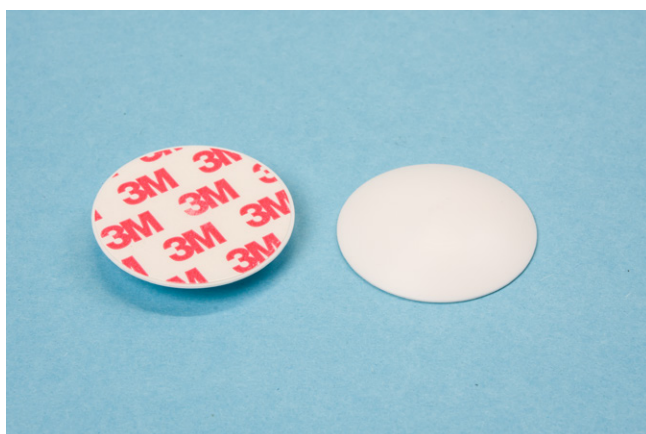
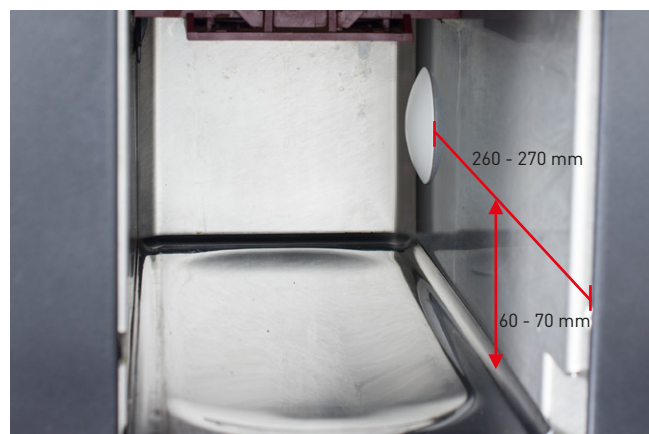
In some machines, the grounds container is not correctly detected if it is situated a bit too far to the right.

In this case, the ABS buffer (074789) can be affixed to the right rear area of the grounds container shaft. This presses the grounds container farther to the left and it is correctly detected by the sensor.

- ▶ Clean the adhesive surface.
- ▶ Pull the protective film of the sticker from the rear side and affix the buffer.

The ABS buffer is installed from S.N. 1808.../
