Service Memo

2019-004

Machine: Schaerer Coffee Soul
Titel: Check screw outlet

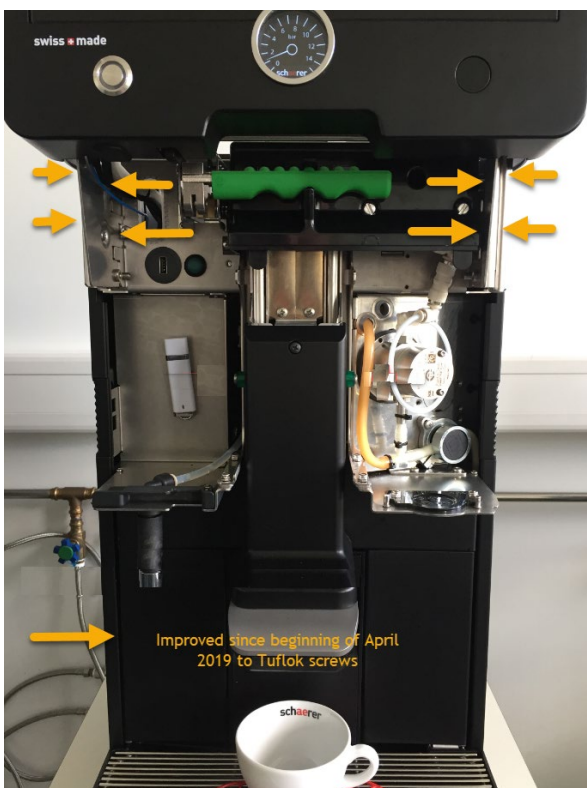
Schaerer found out that the screws with the green rubber for the outlet might become loose. This has no big impact on the machine or its functionality and no danger as well. Schaerer will change to longer Tuflok screws M4x18mm in the future. Please check them during the next visit and if needed use Loctite.

Further they have checked all the 8 screws for the touch panel and as a preventive measure they changed to Tuflok screws. Since one month they are using screws with Tuflok to ensure that they will not getting loose. That means all machine before beginning of April have the screws without Tuflok. Schaerer suggest to check them during the next visit and in case that they are loose, use some Loctite.

Below you will find a picture from the front, there you can see which screws are affected.

Please inform your technicians for their next visit to a Soul, that they should check these screws and if needed to fix them with Loctite.
