T.I. no.: 2021 - 03 Updated: -	Topic: Mounting bracket for grinder cover
-----------------------------------	---

Grinder cover fastened with PT screw

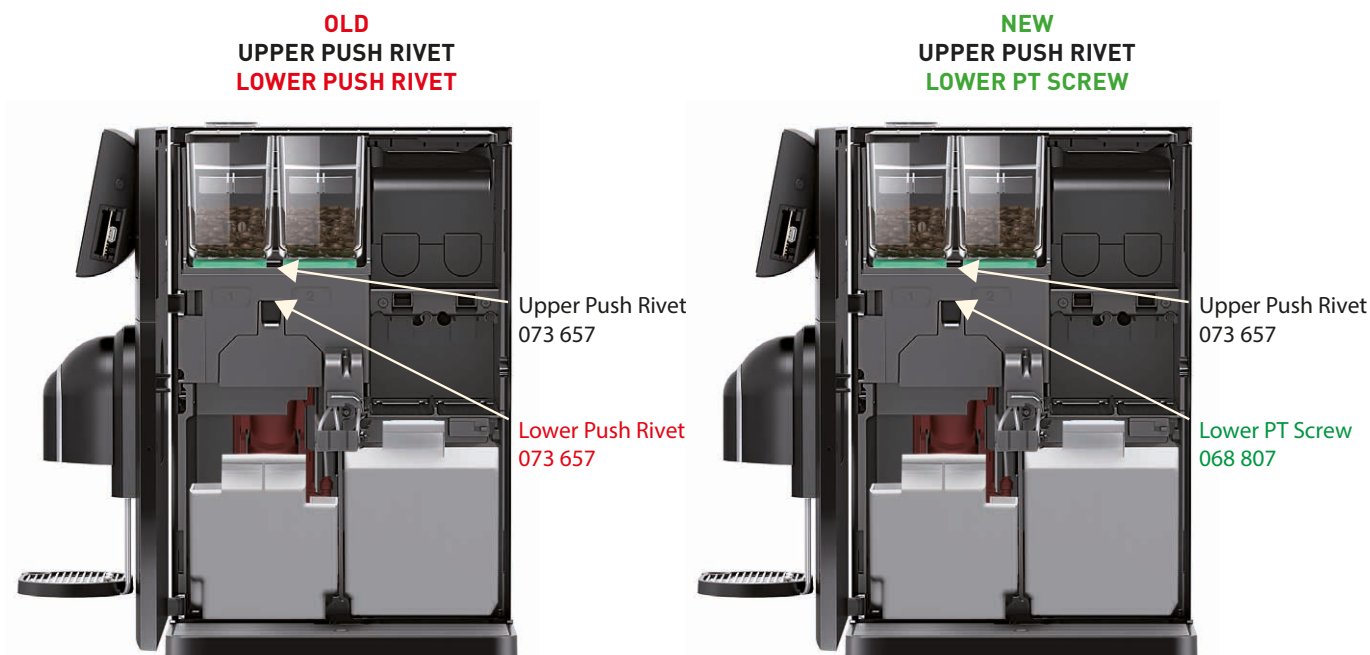
Grinder cover 072 901 of the Schaeerer Coffee Prime was previously fastened with two push rivets 073 657. The lower push rivet did not sufficiently perform its holding function and frequently fell out.

From serial number 2023/XXXX, lower push rivet **073 657** will be replaced by PT screw **068 807**. The upper push rivet remains unchanged.

PU screw **068 807** is self-tapping and can be screwed into the existing hole.

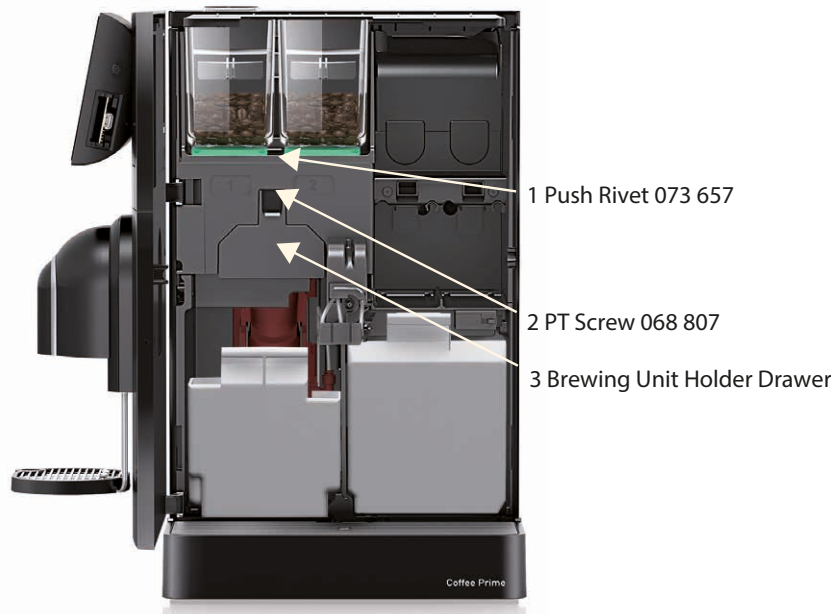
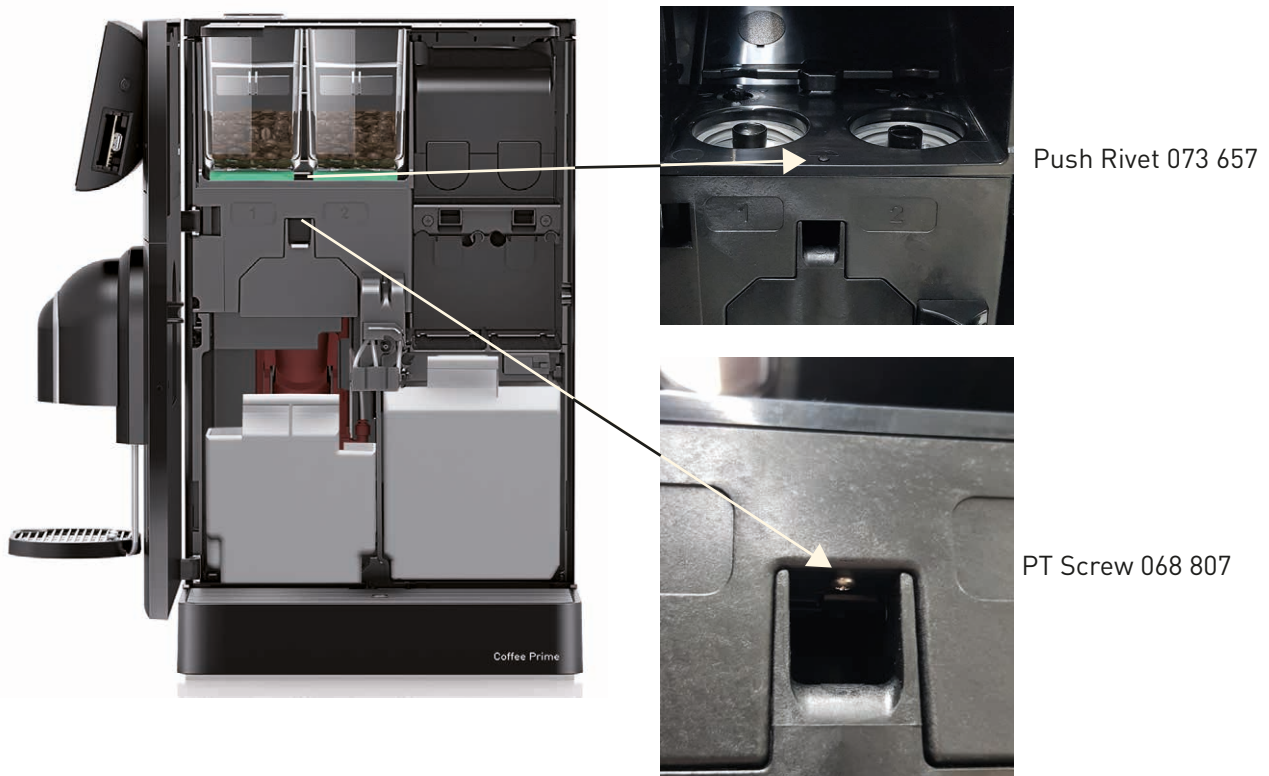
Disassembling grinder cover

To avoid damage to the grinder cover during disassembly, observe the following sequence

- ▶ Pull out brewing unit holder drawer **pos. 3**
- ▶ Remove push rivet **pos. 1** and PT screw **pos. 2**
